# Sample evidence pack

# Location Evidence Pack

Flat 9, Ashcombe Court (fictional)

Damp and mould growth

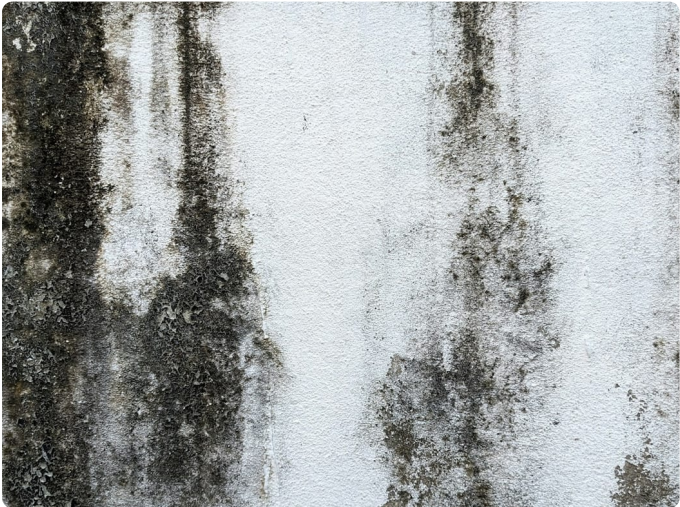
3.4 Original tenant report

Condensation on every window and mould on the bathroom grout and ceiling.

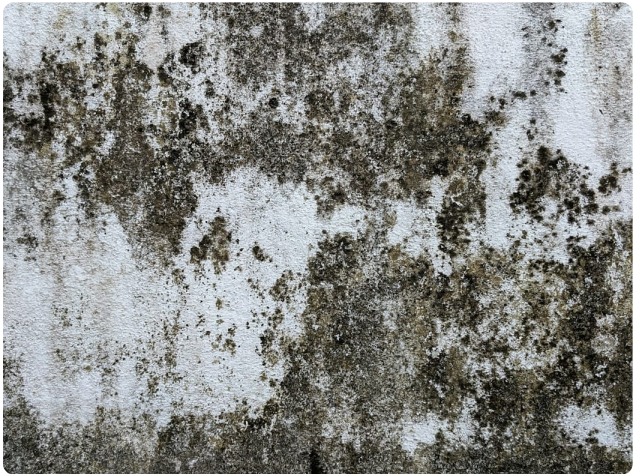
Before work

| Root cause | Condensation |
| Location | Bathroom, Above the bath, external wall |

Diagnosis comments  
No working extractor in the bathroom and the window is kept shut. Consistent with the tenant's report of mould returning after showers.

| Completion notes | Fitted a humidity sensing extractor fan and a trickle vent. Treated the wall with a mould wash and redecorated. Talked the tenant through running the fan after showers. |
